The Keys to Success in Waikiki

Alison Savage, P.E., and Michael Terry, P.E., Hayward Baker Inc.

International Market Place | Waikiki Beach, Hawaii

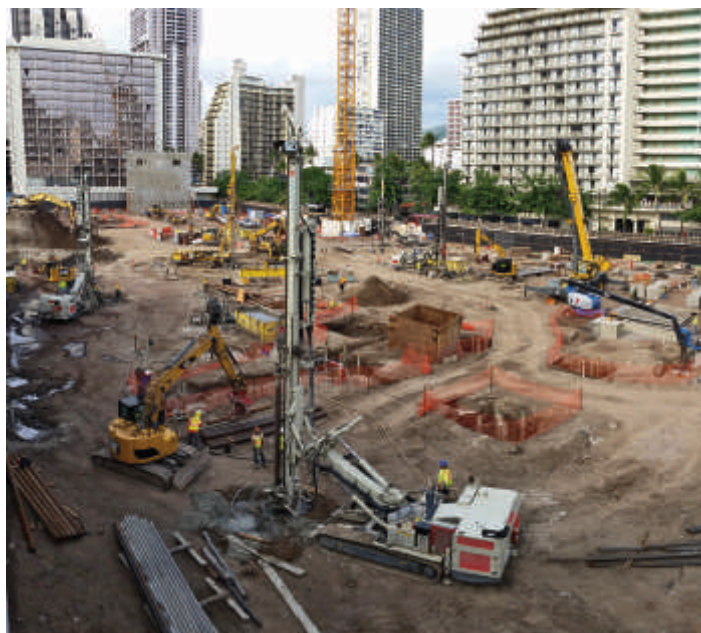
Production micropile drilling

The production plan included the use of up to six drill rigs with one spare on site to meet the project schedule. A Casagrande C14 as well as Comacchio MC-22s and MC-28s were used to install the piles. The micropiles were installed by first flushing the outer casing into the ground using water. The starter pieces of casing had 'J' shaped carbide-tipped drill teeth welded to their end sections. Taking note of the typical depth to bond zone soils/rocks in the vicinity; the outer pipes were flushed to refusal or about 10 ft (3 m) above the bond zone materials. An inner string of drill rods was then added with roller bits and extended 1 ft (0.3 m) in front of the pipe casing. The remainder of the pile, and particularly the bond zone, was duplex drilled using this arrangement. Typically, 20 ft (6 m) tooling was used. Drill pipe and rods were added using a rod handler mounted on an excavator at each drill rig. After reaching design depth, the inner drill string was pulled and the interior all-thread bar was set to the bottom of the pile along with a flexible tremie pipe. The piles were pumped full of grout from the bottom up. Due to the great length of the micropiles, and the permeable nature of the corraline and basaltic rocks, average grout takes were on the order of

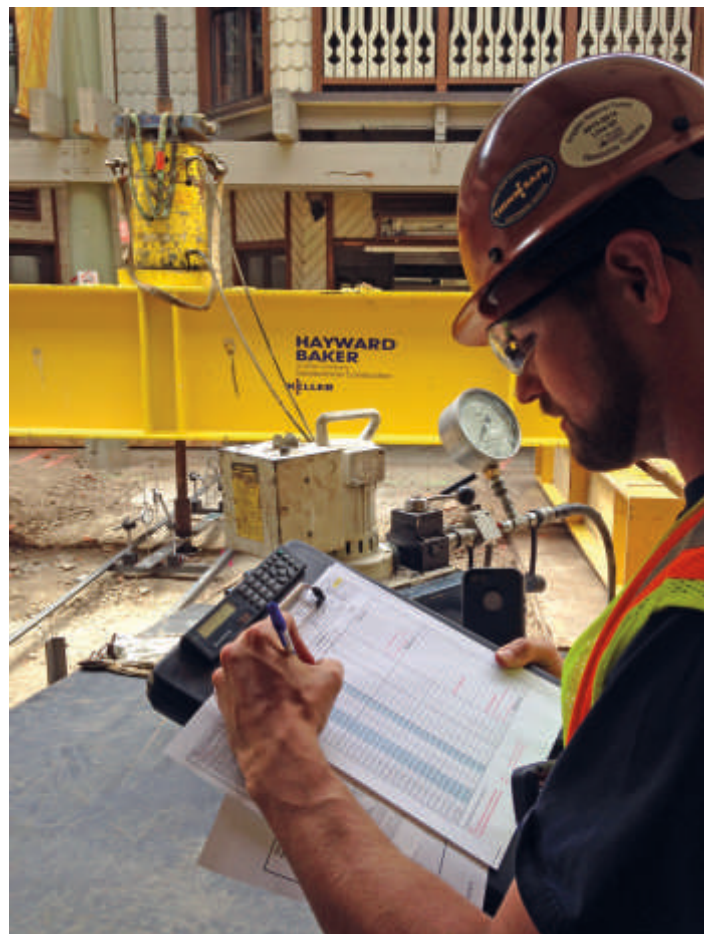
Observing a micropile load test

Five percent of the production micropiles required proof testing according to the specification. The proof test piles were identified by the owner's representative. Full-length bars were installed at proof test pile locations during construction to allow for tension testing. Thirty-five proof test piles, tested to 1.33 over the design load, were all successfully verified by tension testing over the course of the project, in various areas of the site. Twenty-seven of

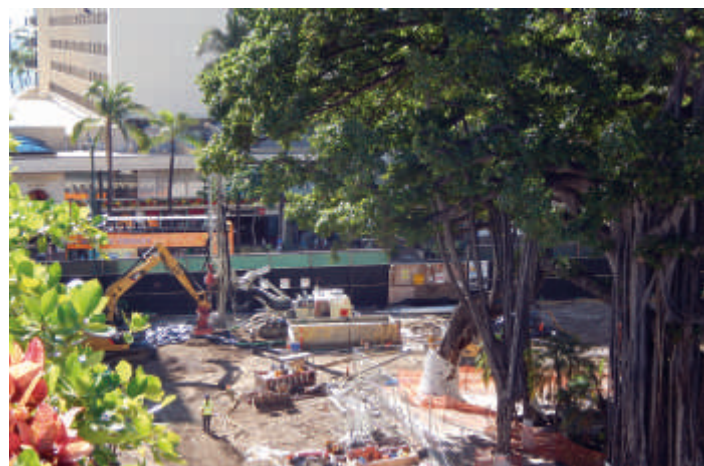
Micropile drilling under the Banyan tree

Most of the piles were installed in unlimited headroom but some micropiles were installed in reduced headroom (20 ft [6 m]) beneath the Banyan Tree. At those locations, a Comacchio MC-602 drill rig was used in the lowest overhead conditions. In addition, the tree roots were carefully investigated and trimmed sparingly by a specialist.

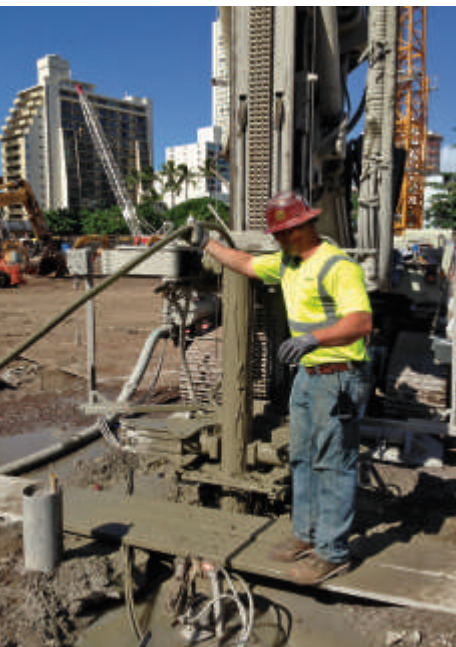
Tremie grouting a micropile
